# Ocean Engineering

## Review

# Pipelines, risers and umbilicals failures: A literature review

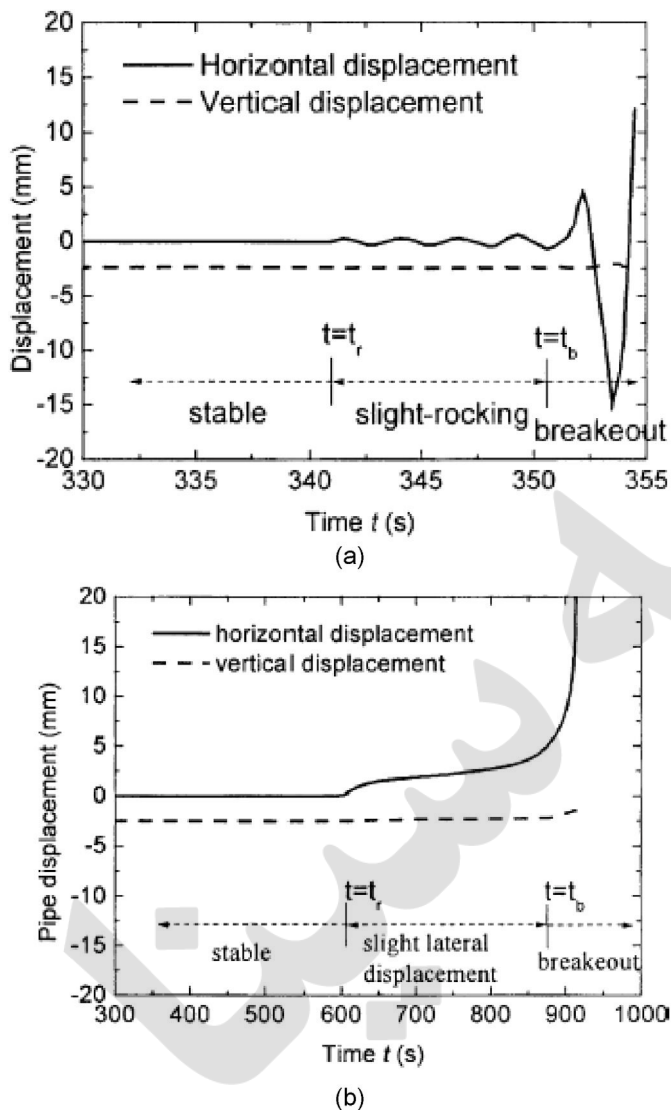
Fig. 3. Typical pipe displacement-time curves: (a) in waves; (b) in currents (Gao et al., 2007).

More recently, Gao et al. (2007) compared the results previously shown for the pipeline stability in waves with those in currents. This comparison is summarized in Fig. 3, where it can be noticed that under wave loading, after the fully stable stage, a slight rocking stage of the pipeline takes place. The time durations of both stages are approximately the same. Finally, in the last stage, the pipeline suddenly moves back and forth with large horizontal displacements, i.e., the pipe loses lateral stability (Fig. 3(a)). However, under the current loading, the pipe pushes the soil nearby ahead with a slight lateral displacement in the stream direction, instead of with slight rocking, after the totally stable stage. In the stage of the pipeline losing stability, the pipeline in the currents moves with large displacements only in the stream direction (Fig. 3(b)). Regarding the linear relationship between the pipe weight parameter and hydrodynamic parameters, developed by the authors in 2002, different relationships for pipeline lateral stability in waves and in currents were found, indicating that the pipeline directly laid on the sandy seabed in currents remains more stable than in waves for the same level of flow velocity.

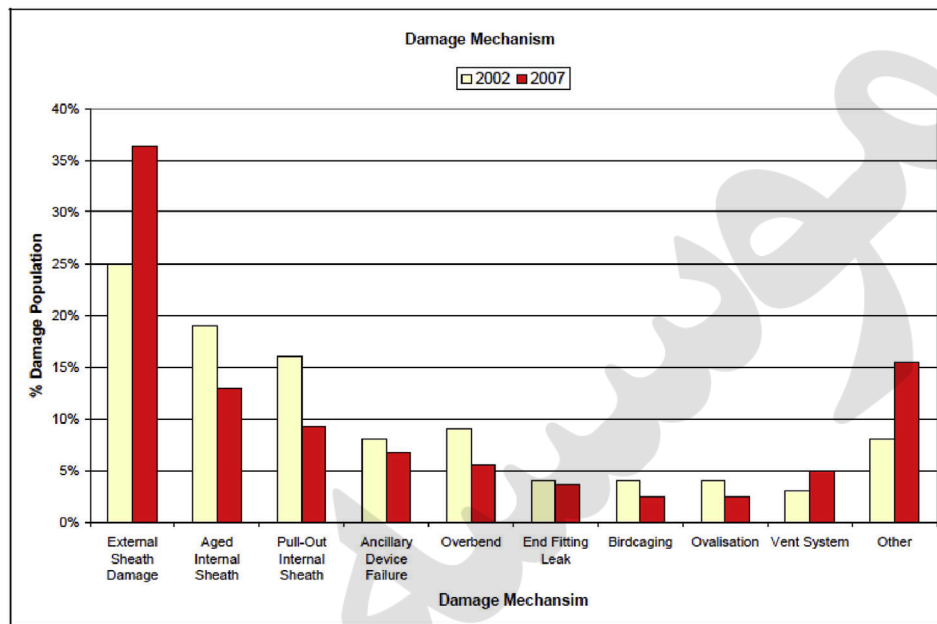
Fig. 5. Chart showing the most significant causes of flexible pipe damage in 2002 and 2007 (Saunders and O'Sullivan, 2007).

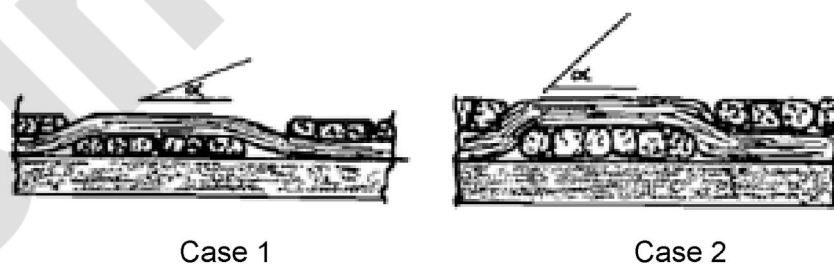
Fig. 6. Comparison between low and high packing in aramid braid (Bryant, 1990).

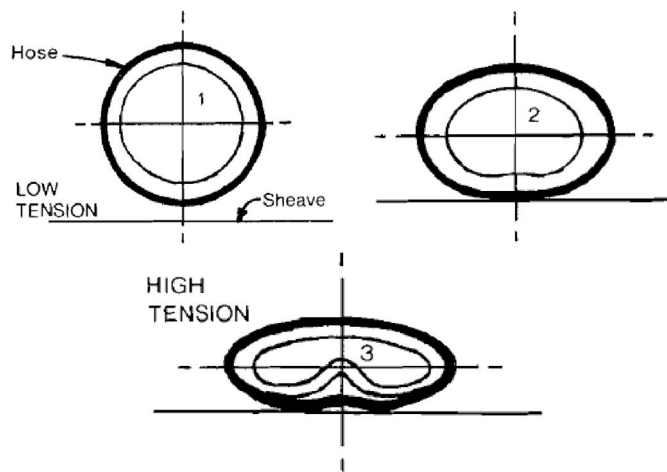
Fig. 7. Hydraulic hose failure by sheaving (Bryant, 1990).

As represented in Fig. 7, the stages of sheaving failure in hydraulic hoses comprise a transition between a perfect circular hose (1), an oval hose (2), and a point (3) at which the lower surface turns in on itself. At this point, the inwardly pointing material will be 'chased' along the axis of the umbilical as it is pulled along over the sheave. In some cases, this type of damage is recoverable by re-inflating the hose, but the material life will certainly be reduced. In other cases, the heart-shaped geometry is so pronounced that it resists inflation and subsequent bursts will occur due to the separation of the braid from the liner.

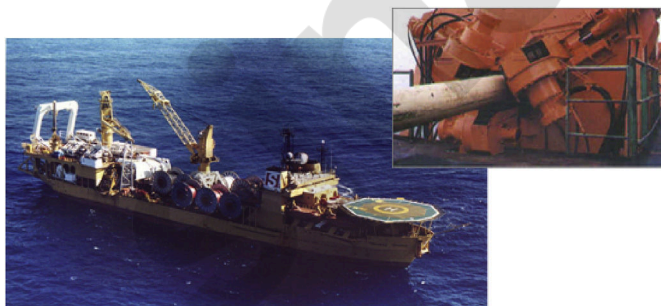
Fig. 8. Pipe laying support vessel (PLSV) and its tensioner (Rabelo, 2013).

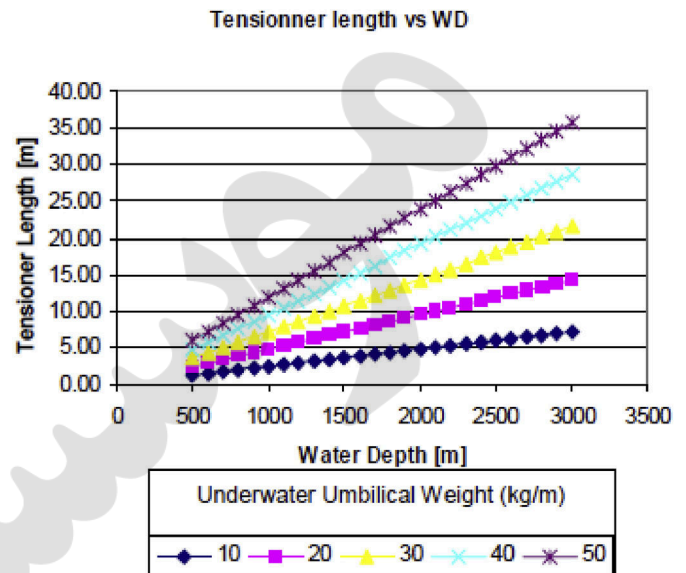
Fig. 9. Tensioner Length versus water depth and umbilical weight (Dieumegard and Fellows, 2003).

the load being transferred, the lower dynamic friction coefficient between the external coating and tensioner shoe structure, the length of the tensioner and the number of tensioners which will be effectively employed. The maximum radial compression specified (design crushing load) is dependent on the active traction, because this could end up stretching the wires of the armour and inducing the effect of crushing (squeeze) in the inner layers. Dieumegard and Fellows (2003) describe the design and installation of a deepwater metallic tube umbilical and give reference to the total length of tensioner required to install it under several water depths and umbilical weights. As shown on Fig. 9, the total length of tensioner required to install an umbilical in ultra deepwater can be significant.
