Ocean Engineering

Review

Pipelines, risers and umbilicals failures: A literature review

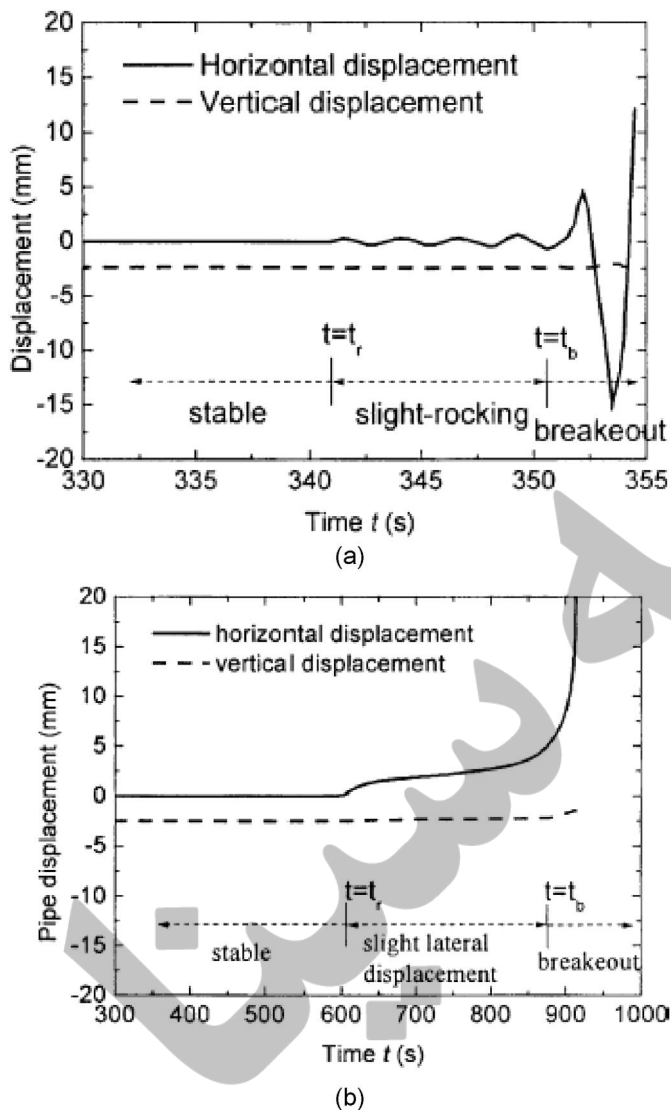
Fig. 3. Typical pipe displacement-time curves: (a) in waves; (b) in currents (Gao et al., 2007).

More recently, Gao et al. (2007) compared the results previously shown for the pipeline stability in waves with those in currents. This comparison is summarized in Fig. 3, where it can be noticed that under wave loading, after the fully stable stage, a slight rocking stage of the pipeline takes place. The time durations of both stages are approximately the same. Finally, in the last stage, the pipeline suddenly moves back and forth with large horizontal displacements, i.e., the pipe loses lateral stability (Fig. 3(a)). However, under the current loading, the pipe pushes the soil nearby ahead with a slight lateral displacement in the stream direction, instead of with slight rocking, after the totally stable stage. In the stage of the pipeline losing stability, the pipeline in the currents moves with large displacements only in the stream direction (Fig. 3(b)). Regarding the linear relationship between the pipe weight parameter and hydrodynamic parameters, developed by the authors in 2002, different relationships for pipeline lateral stability in waves and in currents were found, indicating that the pipeline directly laid on the sandy seabed in currents remains more stable than in waves for the same level of flow velocity.

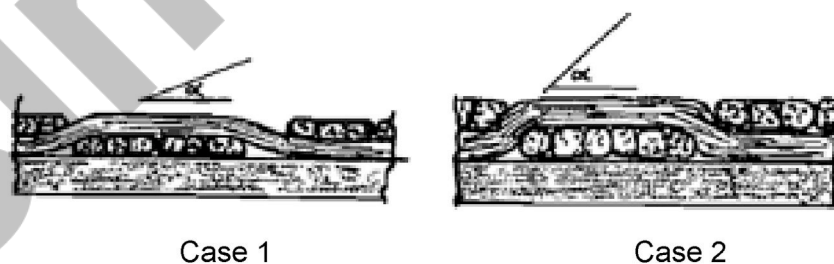
Fig. 6. Comparison between low and high packing in aramid braid (Bryant, 1990).

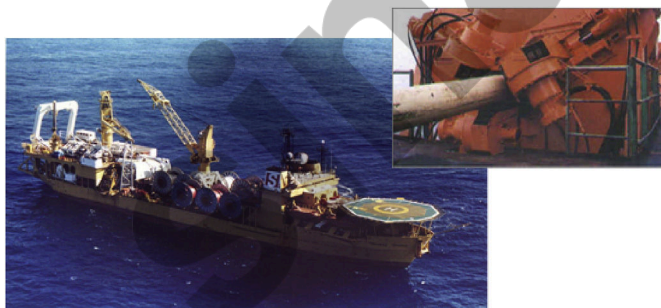
Fig. 8. Pipe laying support vessel (PLSV) and its tensioner (Rabelo, 2013).
